Attack on INS Hanit An Analysis of the Event

By Christopher Carlson

Key Judgments

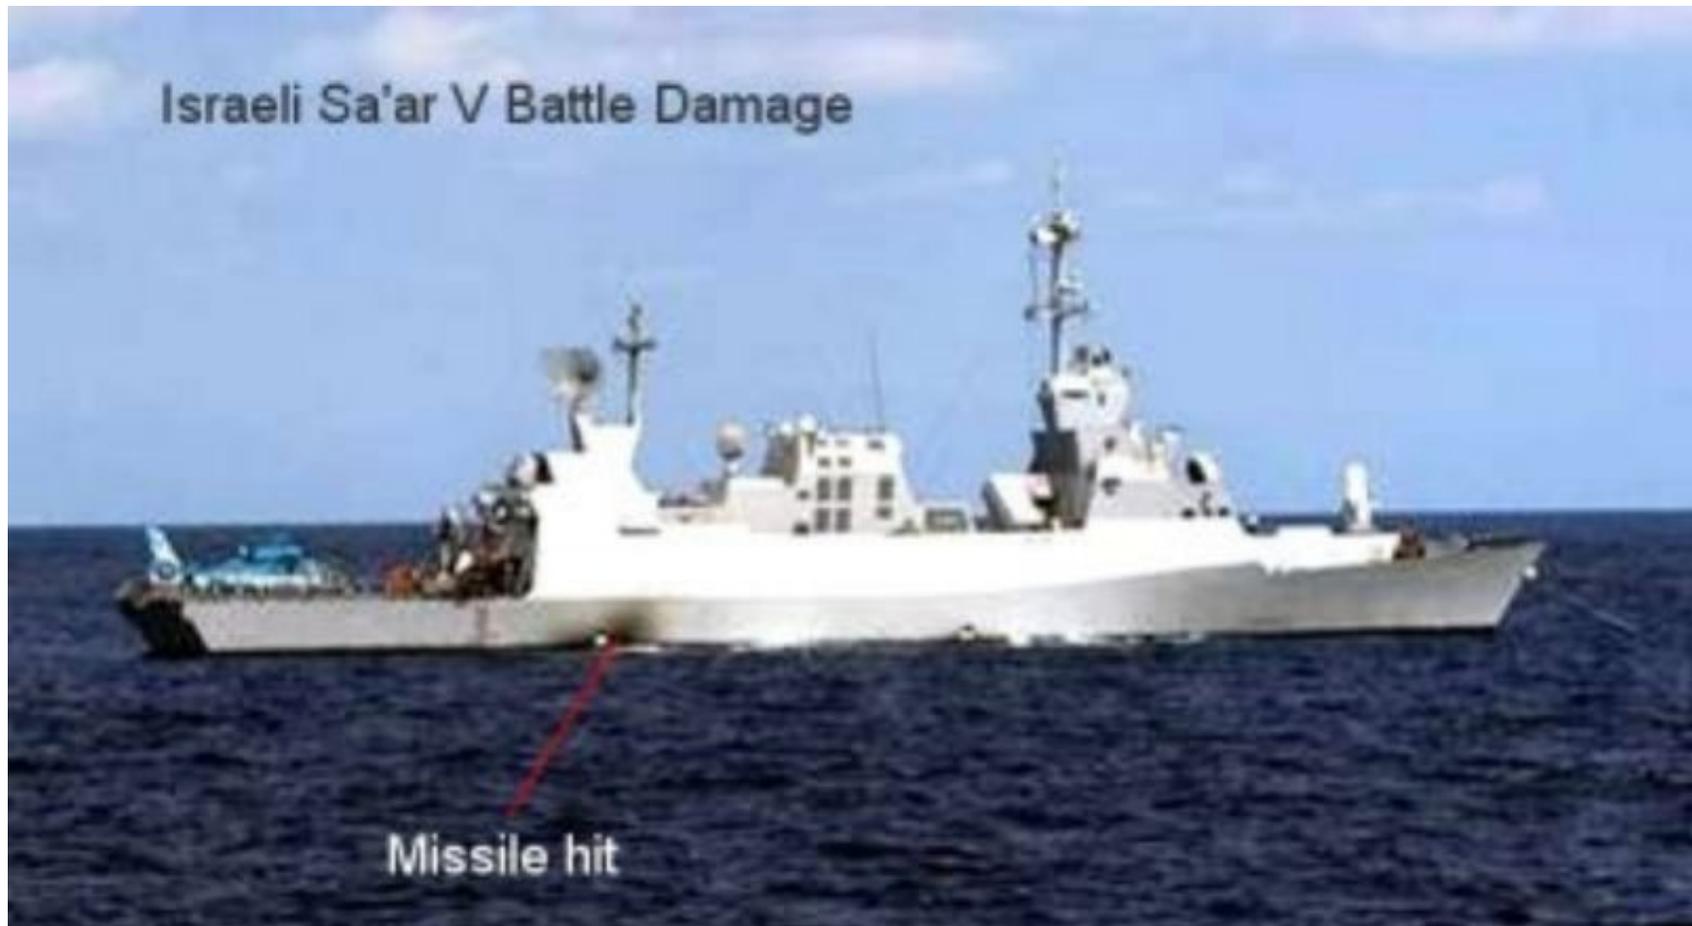
- ◆ **INS *Hanit* returned to the Ashod Naval Base under her own power**
 - **Damage was apparently relatively light given the C802/Noor's warhead size**
 - **Numerous websites and professional journals suggested a smaller missile, such as the C701, had hit the frigate near the waterline**
 - **Photos like the one above noted the black soot aft, suggesting the hit location**

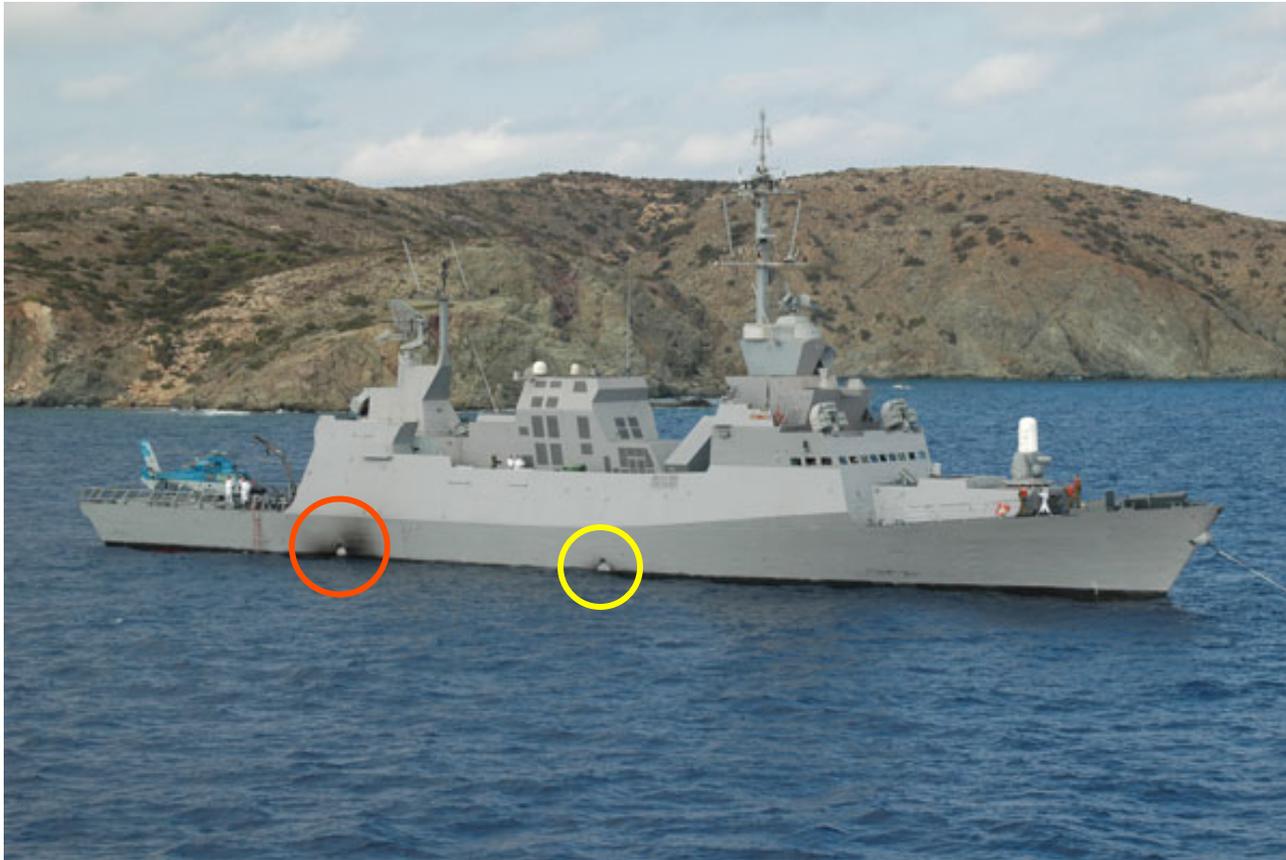
- ◆ ***Problem:*** The proposed hit location (circled in red) is actually one of four diesel exhausts associated with the propulsion/electrical plant
- ◆ The forward exhaust (circled in yellow) was not initially noticed, and there are two others on the port side as well
- ◆ Waterline level exhaust for diesel engines is a common infra-red signature reduction technique

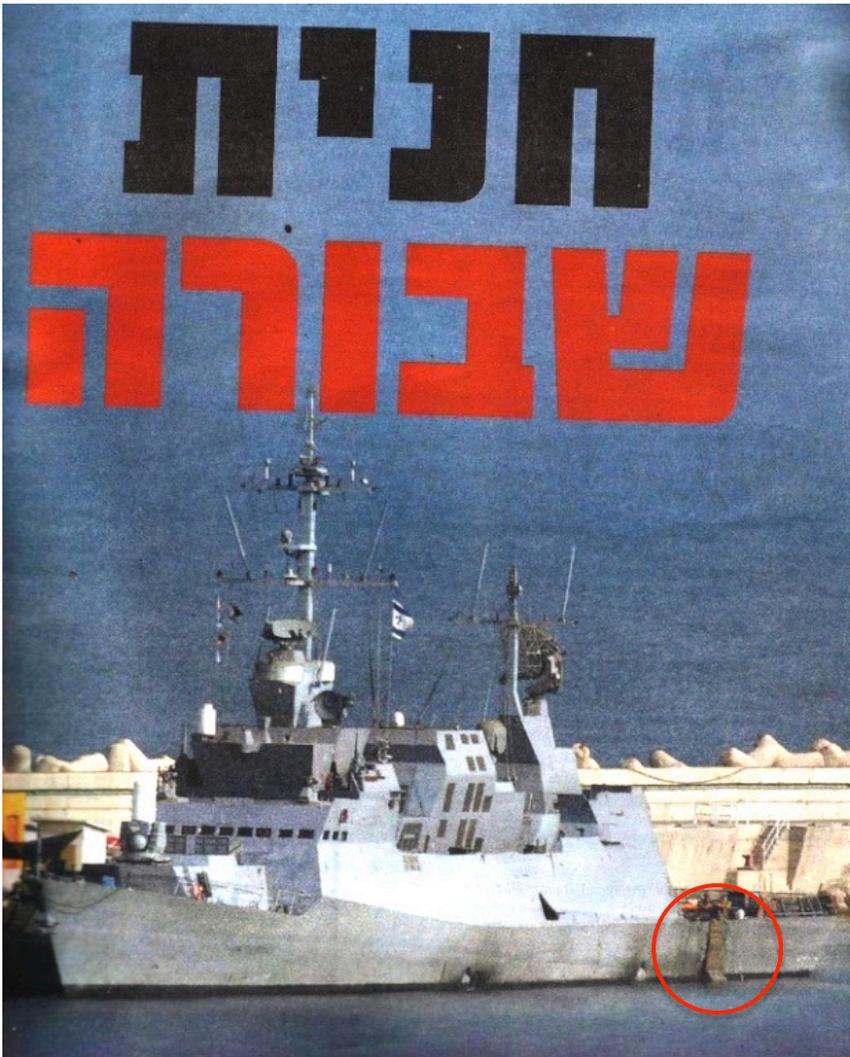
- ◆ A newspaper photo of INS *Hanit* showed very little observable damage
 - Just a mat or canvas covering over the port side, aft of the helicopter hangar
- ◆ This fueled online debates as to the reason for the light damage. The most popular theories included:
 - A smaller missile, such as the C701, hit *Hanit*
 - A larger missile, like the C802, had a proximity fuze and exploded before actually hitting the hull
 - A larger missile hit, but the warhead failed to detonate
- ◆ None of the above theories provide a satisfactory explanation
 - Even a direct hit by a failed warhead would have cause far more damage than what was seen; as in the case of the much larger HMS *Sheffield*

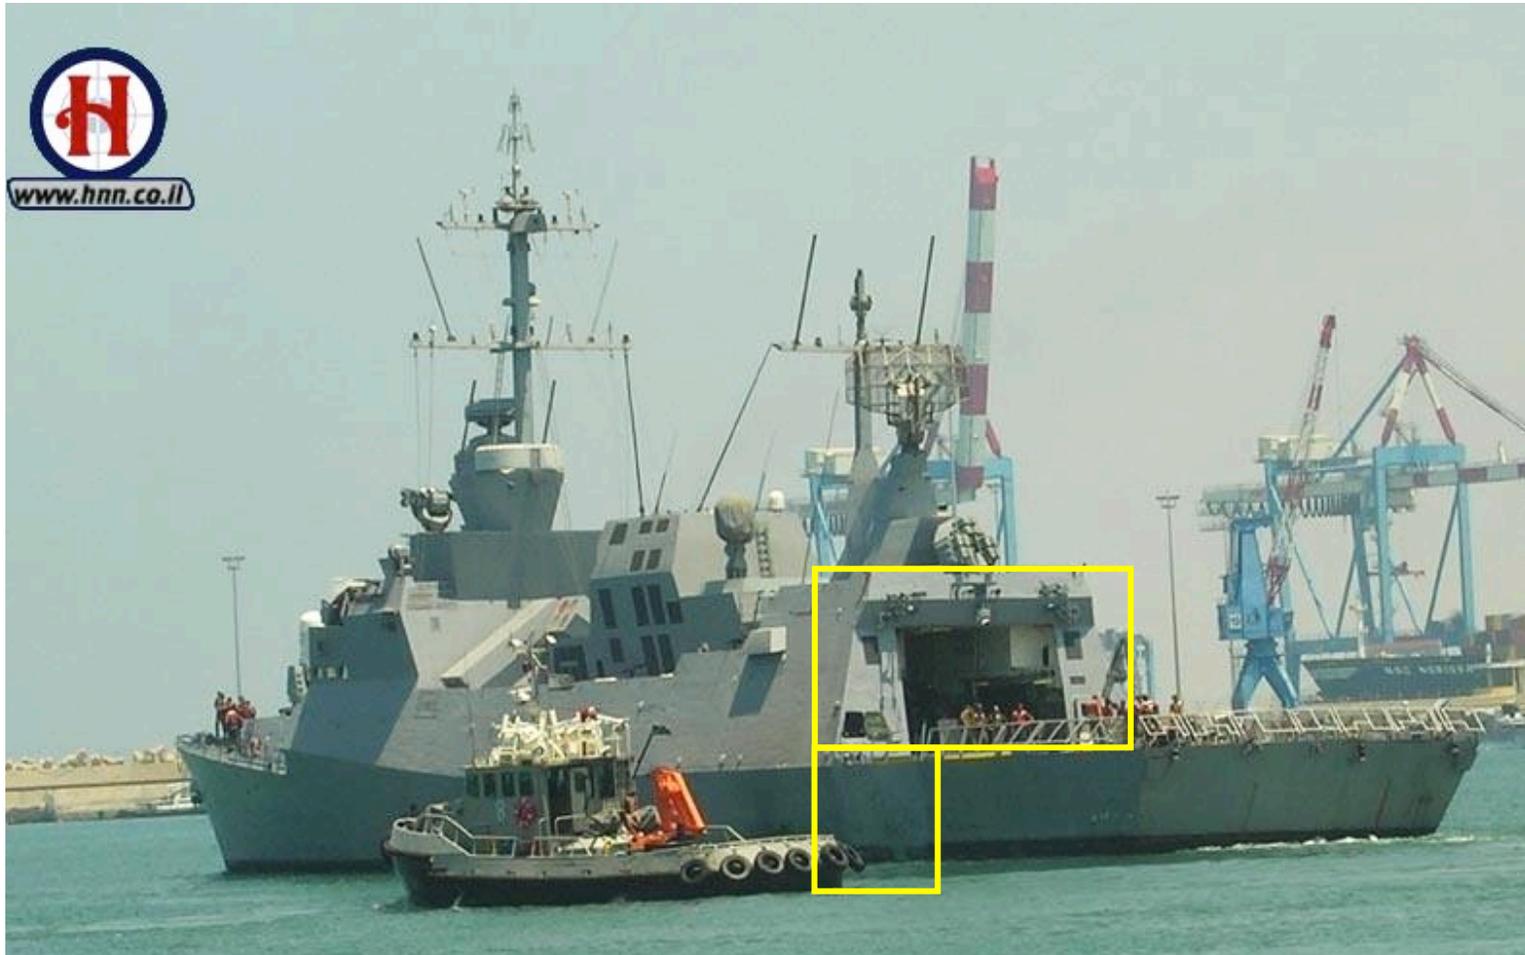
- ◆ **INS *Hanit* was noted underway again on 6 August 2006, a little over three weeks after the attack**
- ◆ **There was no evidence of any significant structural damage**
 - **Repairs from a direct ASCM hit could not have been completed so quickly**
 - **Note the areas of fresh paint and the missing crane**

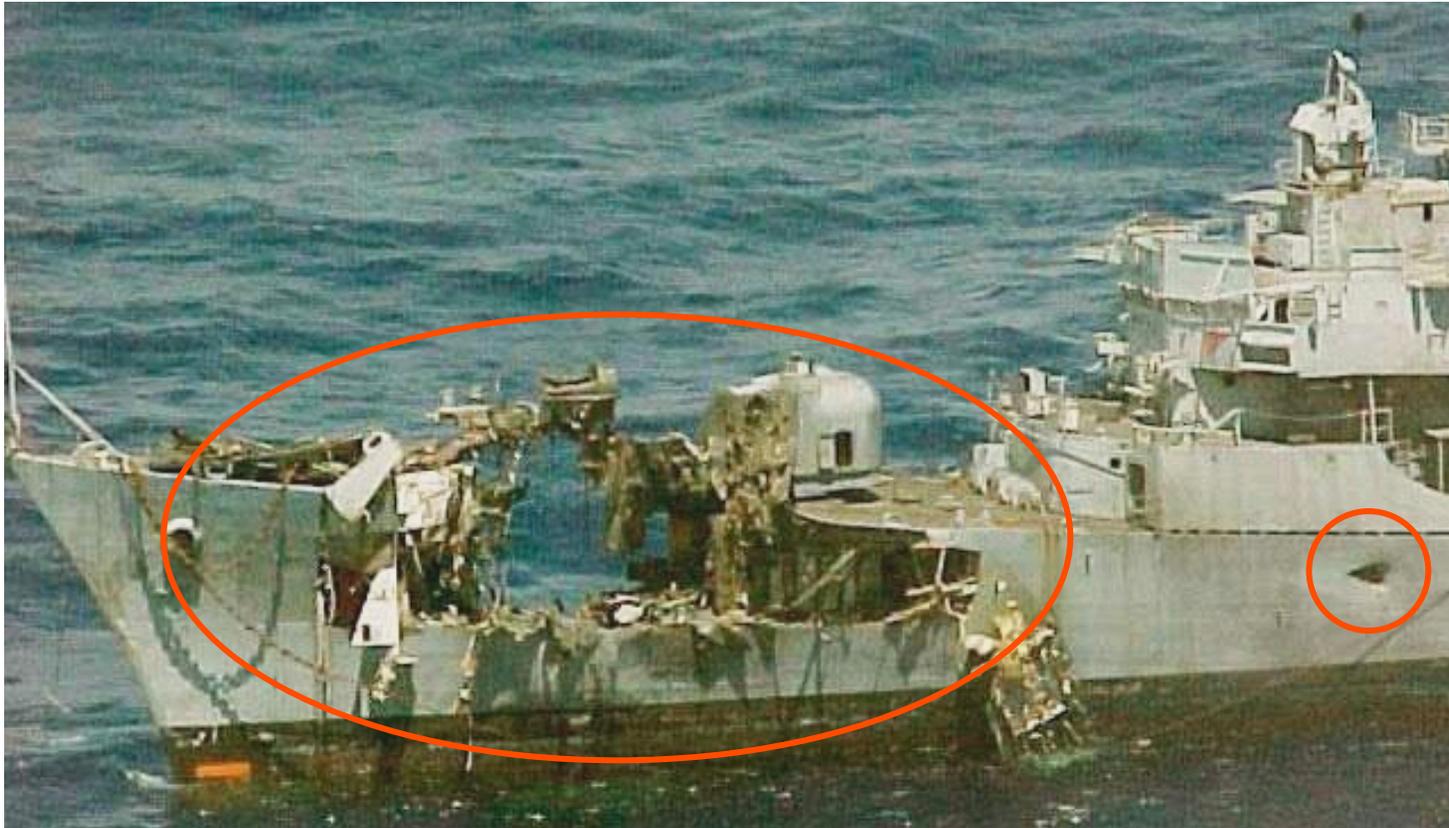
- ◆ Photo is from the SinkEx of the former *USS Buchanan*, DDG-14
- ◆ Small hole is from a Harpoon missile with a telemetry module
- ◆ Large hole is from two warshot Harpoon missiles with real warheads
 - Harpoon warhead: 221.6 kg
 - C802 warhead: 165 kg
 - C701R warhead: 29 kg
 - If INS *Hanit* had been hit by any missile – *it would be obvious*

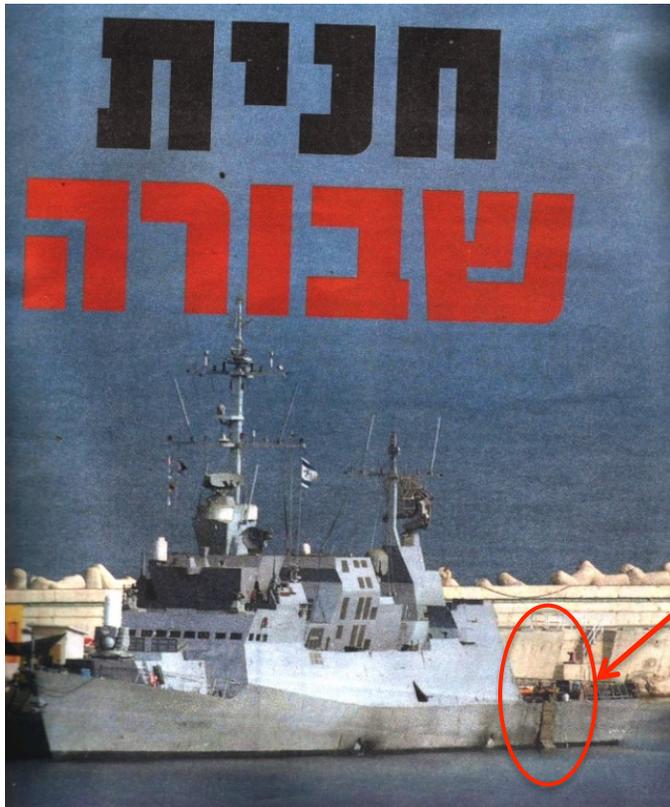
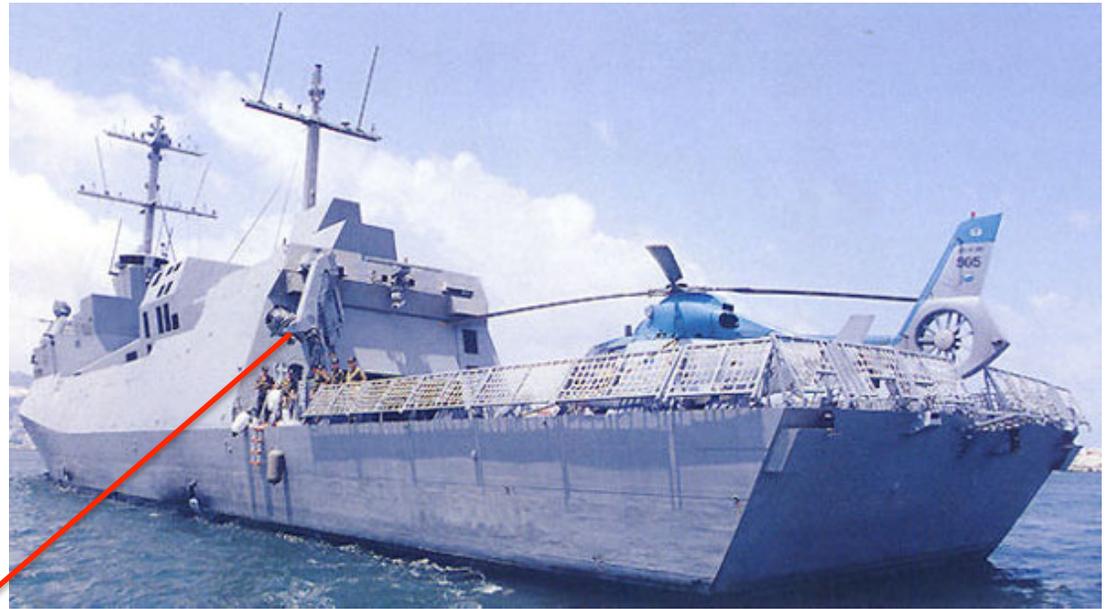
- ◆ **The covered area of the hull is just outboard of where the crane is mounted**
 - Note there is no sign of the crane, although it is possible it was removed
- ◆ **Hitting the crane provides a viable alternative theory**
 - It is a radar hotspot on an otherwise reduced RCS hull and superstructure
 - Crane base is at the right height, a C802/Noor missile's terminal altitude is 5 or 7 meters
 - It is massive enough to take the impact, initiate the fuze, and absorb most of the forward blast and fragments

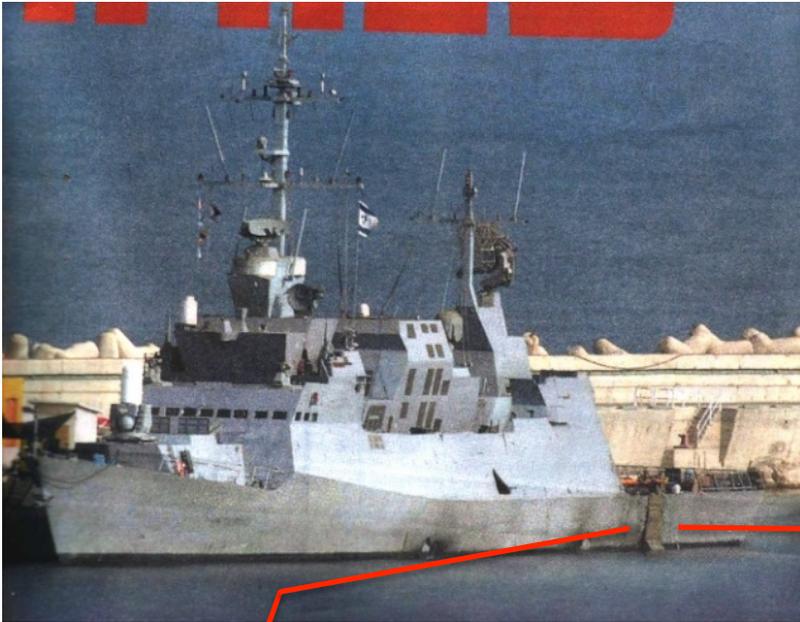
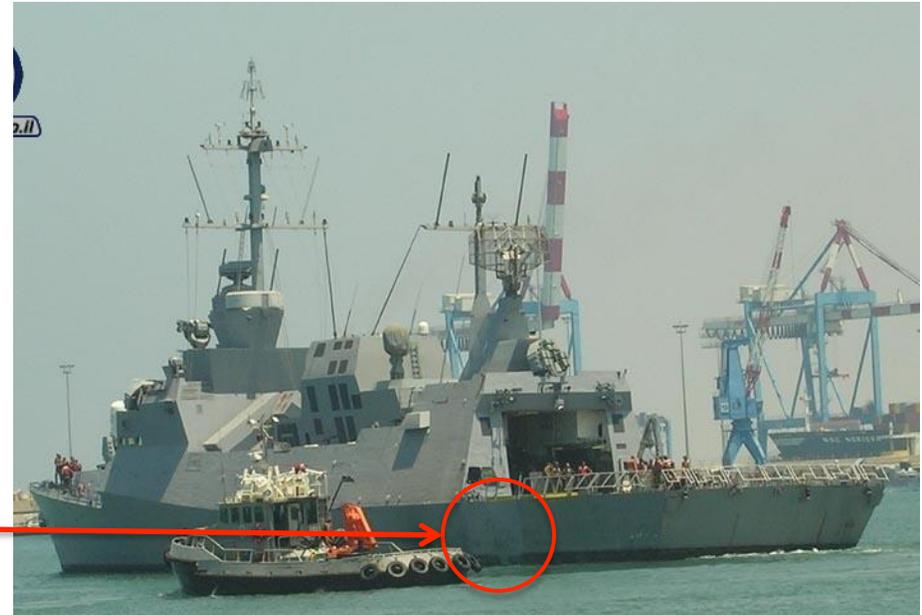
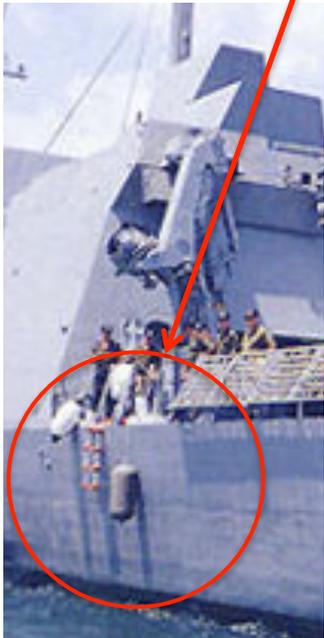
- ◆ The canvas covered hull section matches perfectly with the newly painted hull section on *Hanit* as she left harbor on 6 August 2006
- ◆ That section of the hull is adjacent to where the large crane was mounted
- ◆ Hypothesis was first published in The Naval SITREP: The Journal of the Admiralty Trilogy Game System, Issue #31, October 2006, pages 4-6

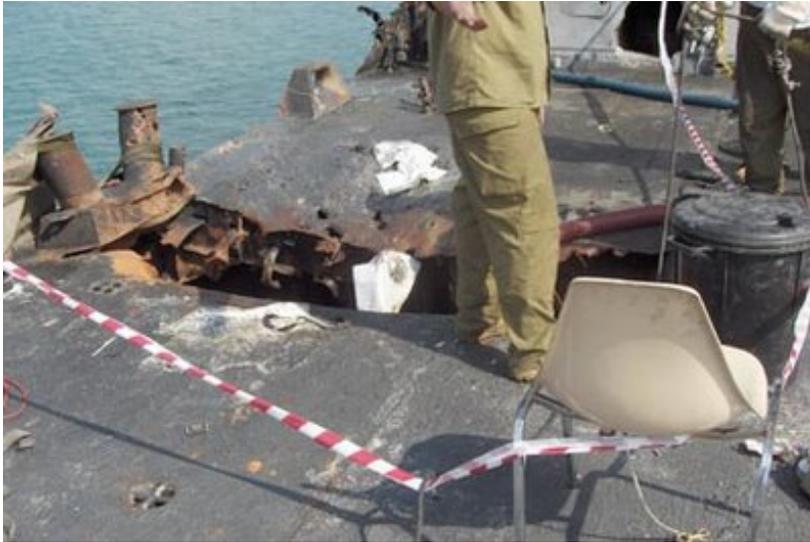
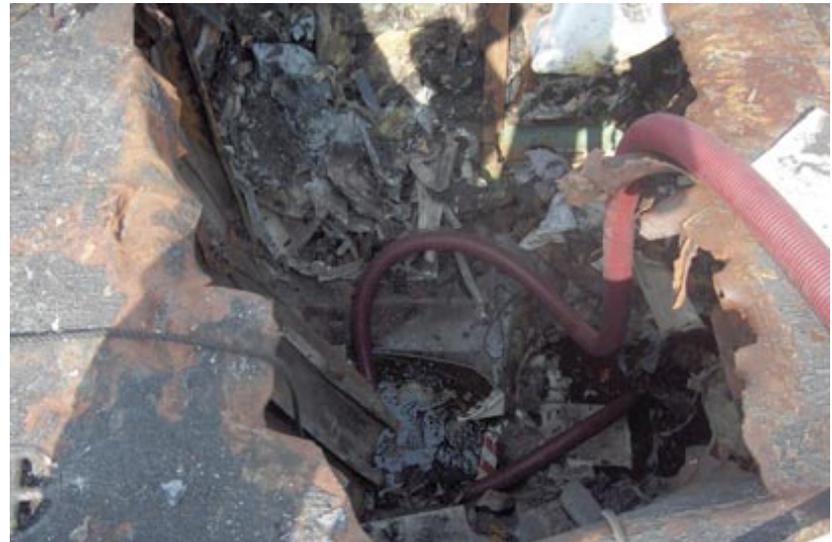
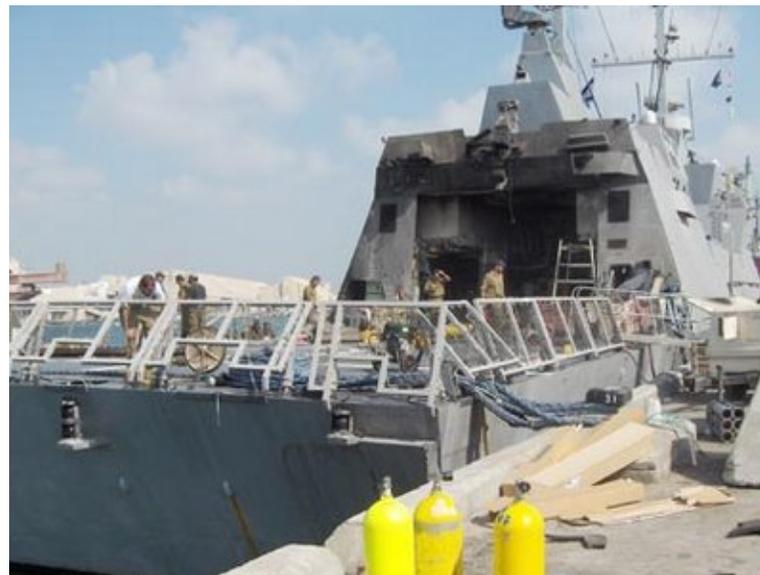
- ◆ In late 2007 and early 2008, photographs of INS *Hanit* at the Ashod Naval Base began showing up on websites illustrating the extent of the damage

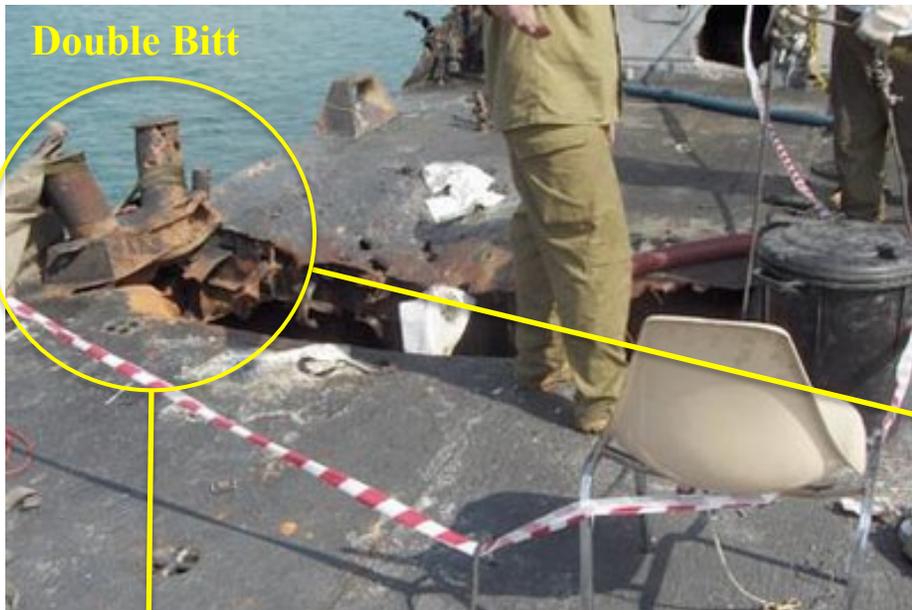
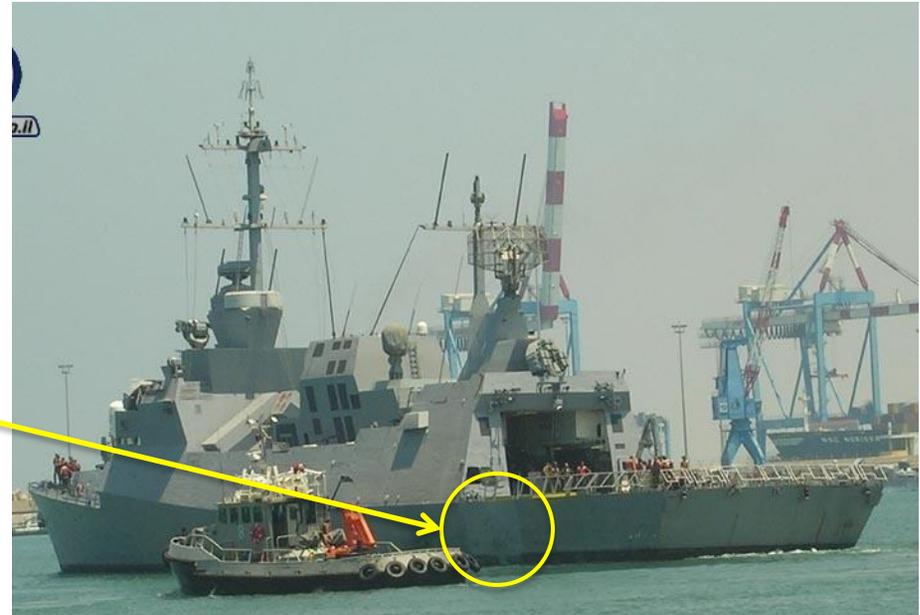
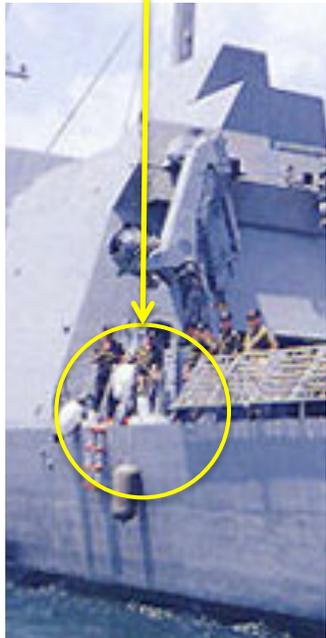
- ◆ **The missile struck the crane aft of the ship's superstructure**
 - Double bitt confirms the hit location of the C802/Noor ASCM
- ◆ **Damage is consistent with a 165 kg multiple EFP warhead**
 - Much of the warhead's damage effects was wasted on open air
- ◆ **Given the orientation of the gash in the helicopter deck, the missile's trajectory appears to have been from directly astern of the ship**
 - Phalanx CIWS, even if it were in automatic mode, would not have been able to engage - masked by ship's superstructure
 - Barak SAM would have had a fleeting chance to engage – but would require automatic mode, this was not selected

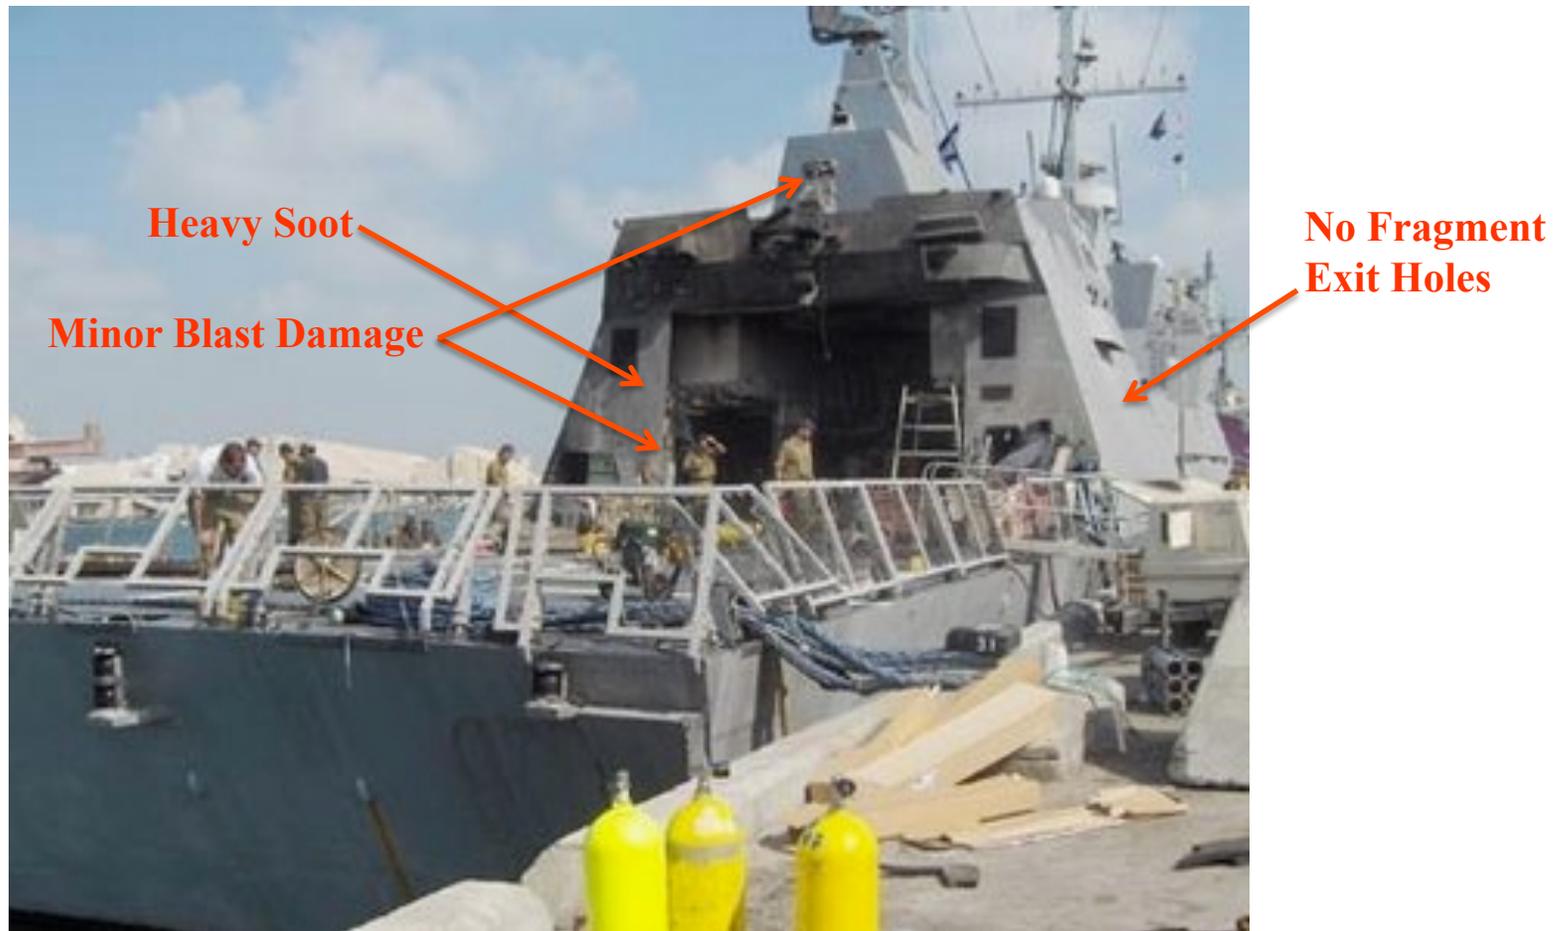
- ◆ **No significant structural damage to the helicopter hangar or aft superstructure**
 - Flimsy hangar door and aft countermeasure launcher were destroyed by the blast
 - No evidence of a direct hit by the missile on any part of the helicopter hangar, note the lack of any fragment exit holes through the side of the hangar
 - Soot on the port side of the helicopter hanger indicates the fire was confined to the deck on the port side near the impact area

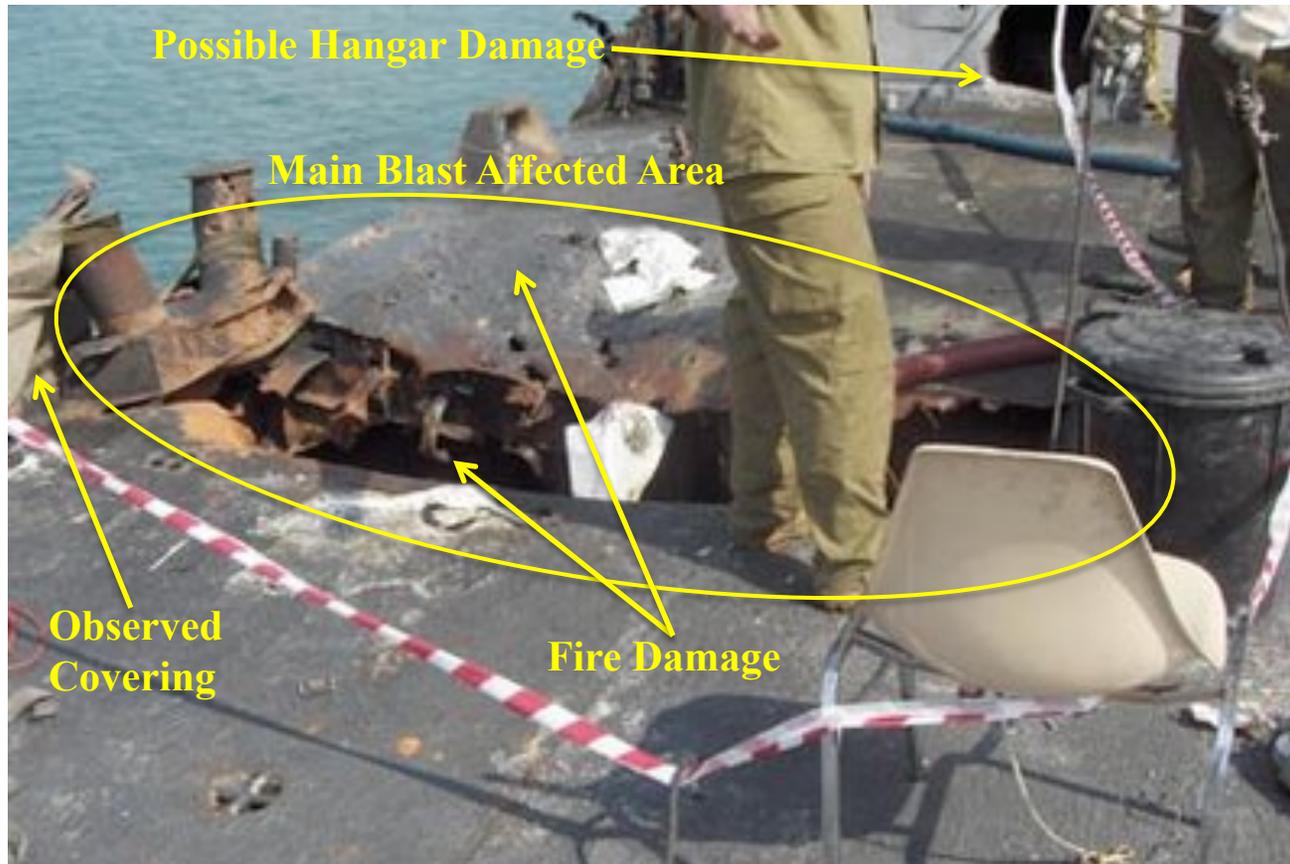
- ◆ **Crane was destroyed, remnants have been removed**
 - Hole in the lower port side of the hangar could have been caused by either a large missile fragment, or more likely crane debris
 - Fire damage topside is forward of the gash and biased to port
- ◆ **Highly localized structural damage to the helicopter deck just aft of the crane's former position is consistent with a multiple EFP warhead**

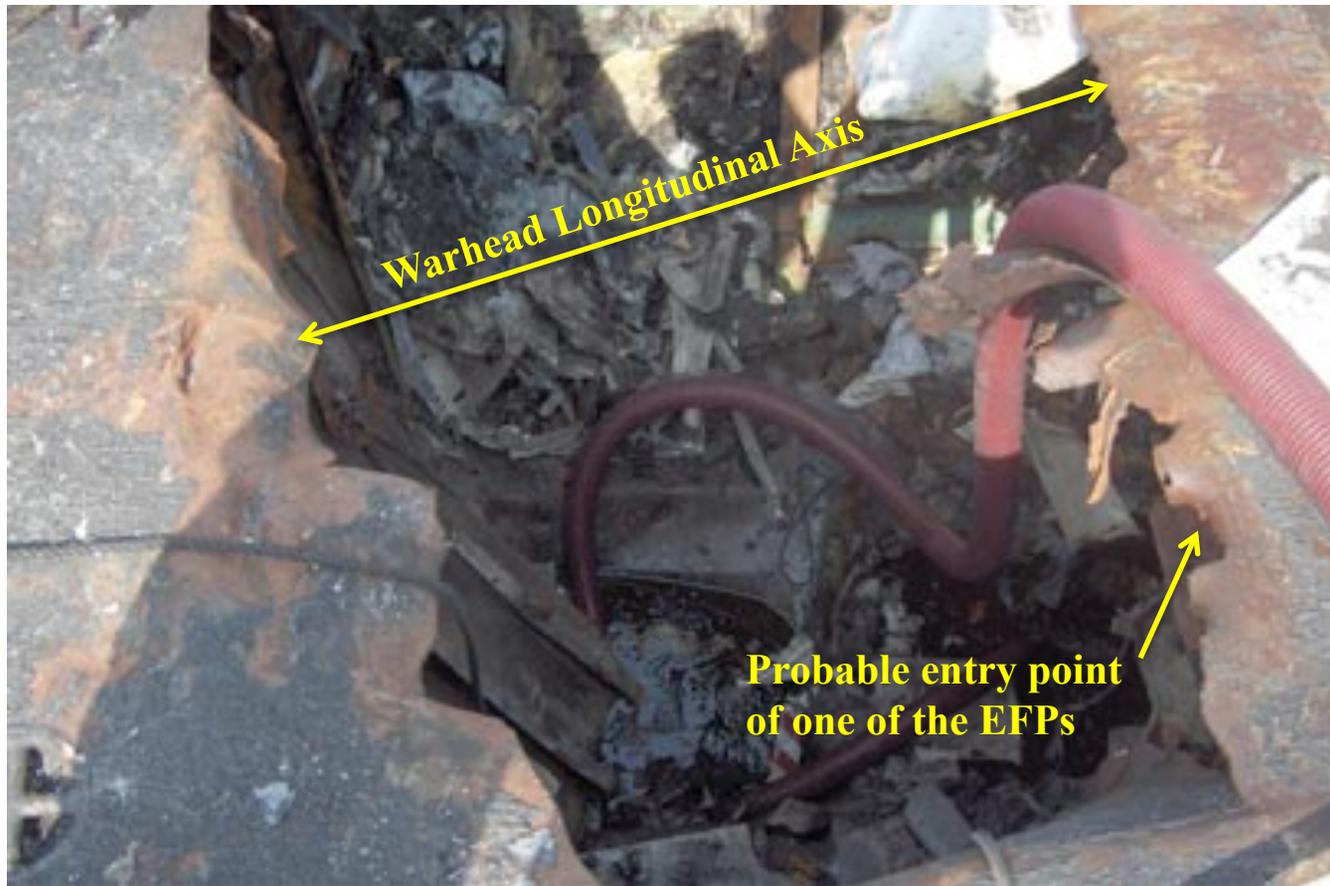
- ◆ **Narrow blast damage swath, strongly suggests warhead detonation occurred close to the deck – less than 1.0 meter**
- ◆ **Evidence of large size fragments that penetrated down into the engineering spaces – very likely caused by an EFP**
- ◆ **Note the significant fire damage**

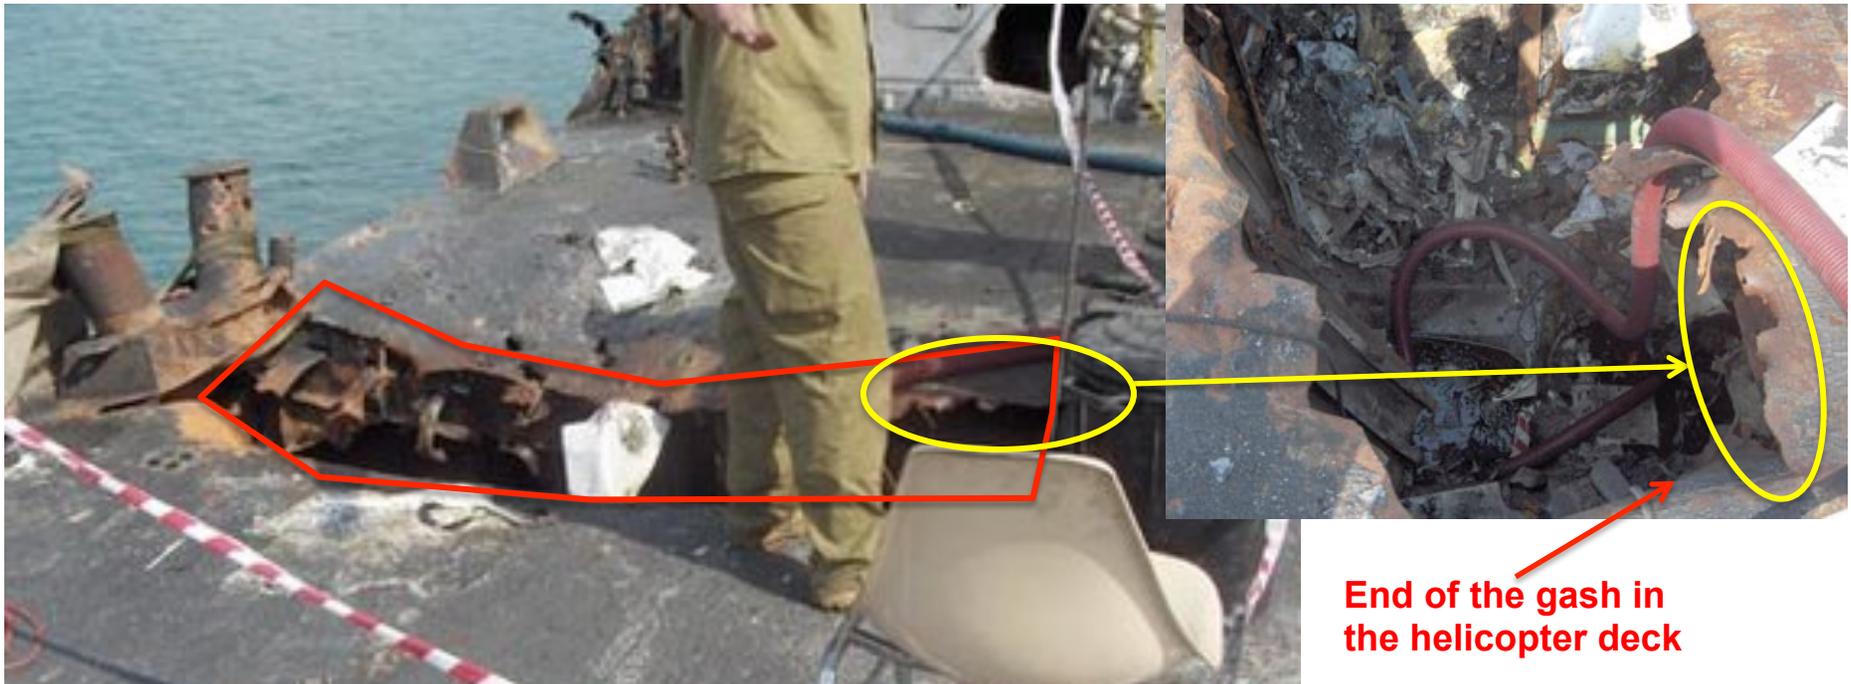
- ◆ Large gash in the helicopter deck is approximately 1.6 to 1.8 meters in length and 0.4 to 0.5 meters in width
- ◆ Damaged area is roughly rectangular in overall shape – consistent with the damage from a C802-type warhead detonating very close to the deck
- ◆ Forward momentum would propel the burning fuel in the direction of the missile's movement – angled slightly to port
 - Remnants of crane protected the helicopter hangar from being splashed with burning fuel
- ◆ Fuel would flow down the dished in portion of the helicopter deck and pour into the gash and other small holes, causing the reported fire below decks
