Attack on INS Hanit An Analysis of the Event

By Christopher Carlson

Key Judgments

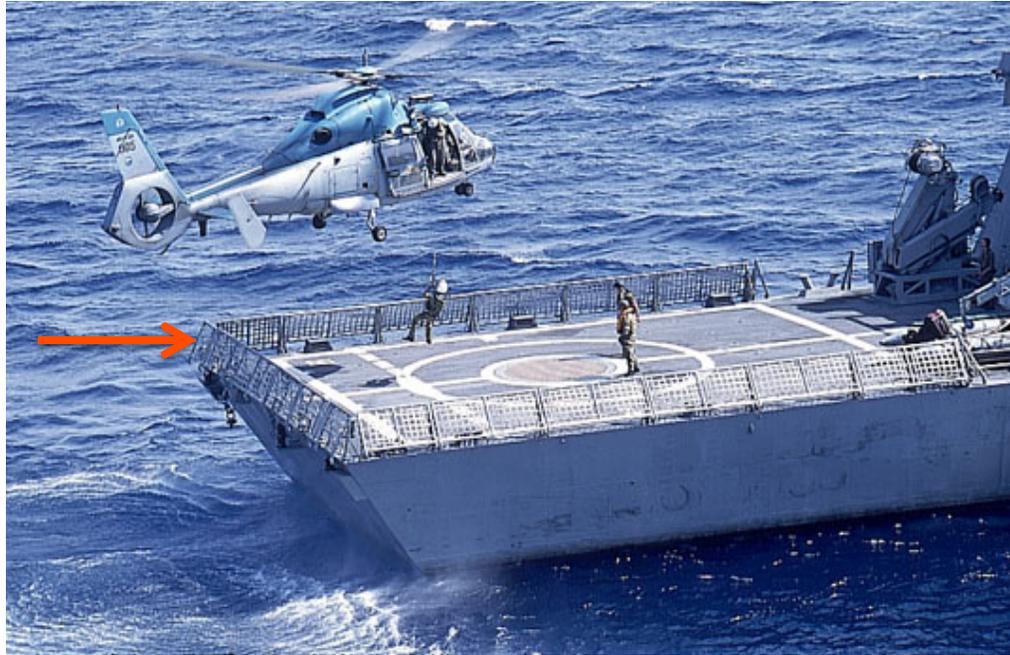
2007 Update

- ◆ The *Strategy Page* website, on 7 February 2007, posted a Tel Aviv news report that discussed the attack on INS *Hanit*
 - Claim is made that the missile struck one of the foldable safety rails surrounding the helicopter deck
 - The peripheral safety net is about 4.9 meters above the water when raised

“The missile that struck the *Hanit* actually exploded after hitting a railing at the rear of the ship and did not penetrate the aft deck. According to naval officials here, the impact destroyed the aft electrical switchboard and caused extensive fire damage, but the fully redundant, highly shock resistant, compartmentalized Sa’ar-5 used its forward electrical power source to return to port.”

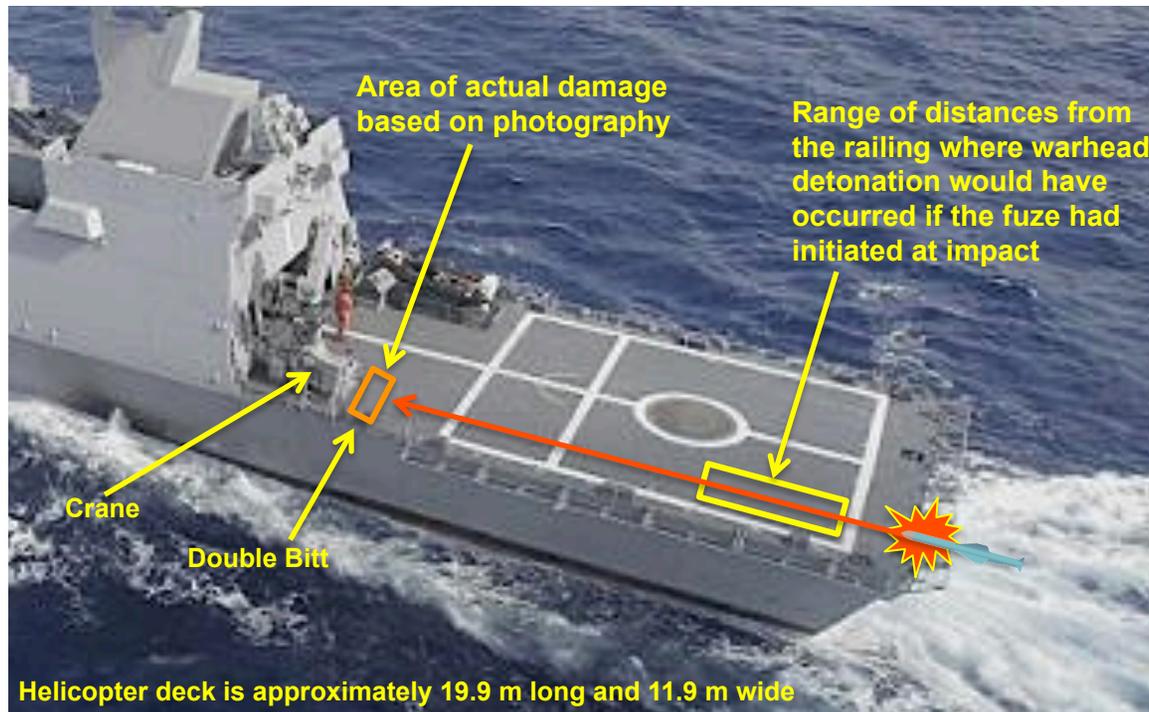
Safety Railing Theory - Unsupportable

- ◆ **If the missile struck the safety railing head on, and the fuze was initiated, the warhead would have detonated quite far away from the crane**
 - Yellow box shows the distances for all combinations of C802 missile speed (Mach 0.8 – 0.9) and fuze delays for blast/fragmentation ASCM warheads (8 – 15 milliseconds)
 - Orange box indicates the area of damage, approximately 2.5 times further away
- ◆ **It is possible that the missile's body, more likely one of the wings, hit the railing, but the contact was not sufficient to initiate the fuze**
 - When raised, the peripheral safety net railing is about 4.9 meters above the water, a C802 at the 5 meter terminal altitude would be at the correct height to strike the railing

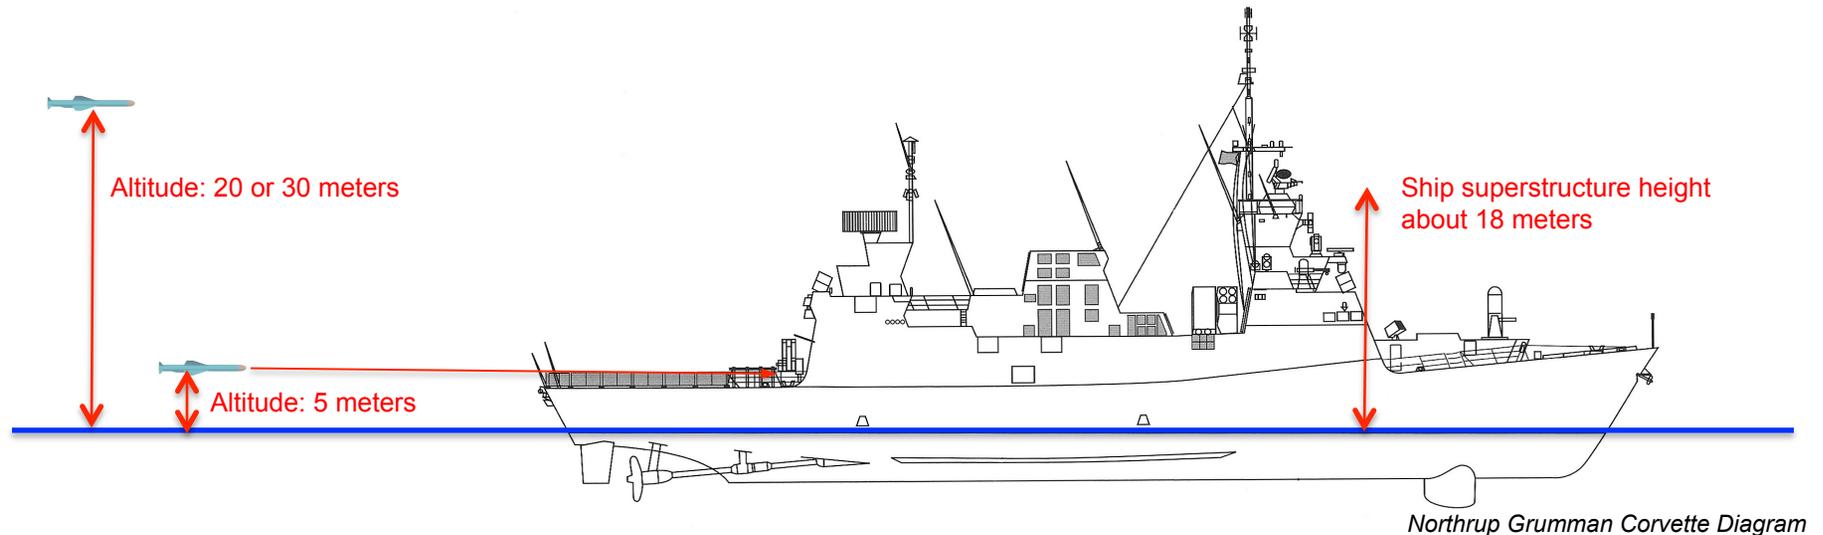
Engagement Analysis

- ◆ **Hezbollah and IRGC personnel fired two, possibly three, C802/Noor ASCMs at INS *Hanit* at a range of about 16 kilometers**
 - One missile reportedly explodes soon after launch (sparse evidence for this)
 - Boost phase lifts a C802/Noor to about 250 meters altitude
 - One missile apparently did not get down quick enough and flew over *Hanit* at or near the cruise altitude of 20 or 30 meters
 - Minimum stated engagement range of the C802 is 15 kilometers
 - This missile continued down range and struck the MV *Moonlight*
- ◆ **The other missile's radar seeker acquired the crane, began homing, and descended to a terminal altitude of 5 meters**

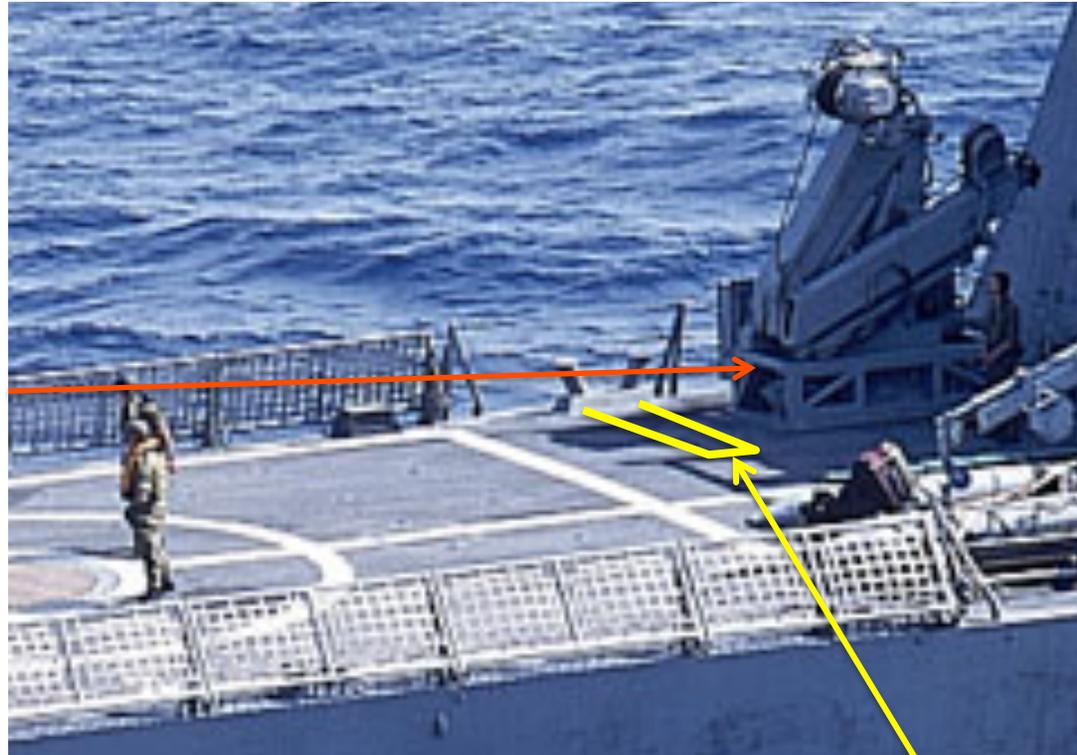
Engagement Analysis

- ◆ **As the C802/Noor flew over *Hanit's* stern, the missile body, or more likely one of the wings struck the safety net railing**
 - **The sudden impact by a wing would create a moment that would rotate the missile's nose downward**
 - **Observed fire damage is forward of the gash in the deck and biased to port, suggesting that the port missile wing struck the railing**
